National Transportation Safety Board

Amtrak Passenger Train 516 Derailment

December 17, 2018

Talgo Series VI Trainset Examination

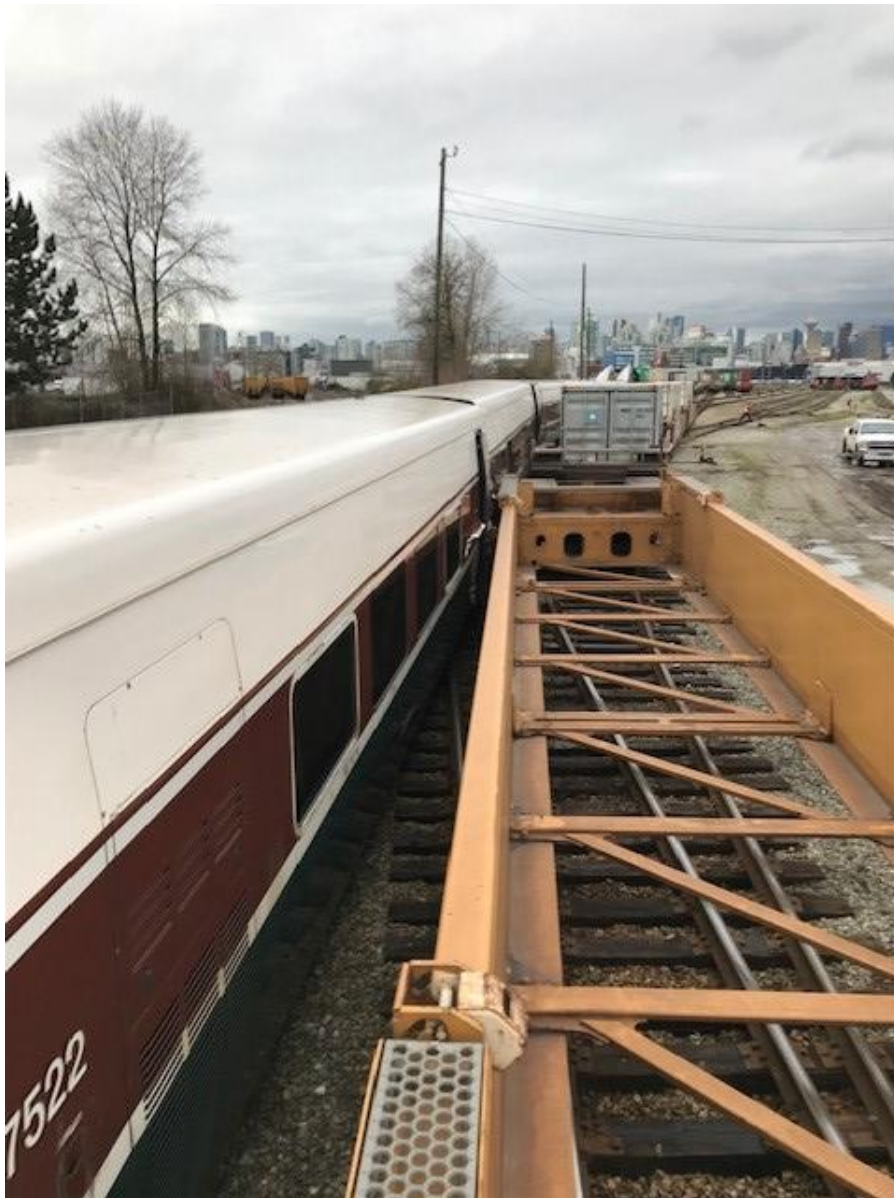
Figure 2. Train 516 derailed into freight cars.

The cars came to rest leaning on freight equipment occupying an adjacent track. Upon inspection of the MX2 switch it was observed to be lined in the diverging move position with a yellow target indication. At the time of the incident, no injuries were reported by employees, or passengers. According to Amtrak, the train was moving at 3 mph when it derailed into the adjacent freight cars.

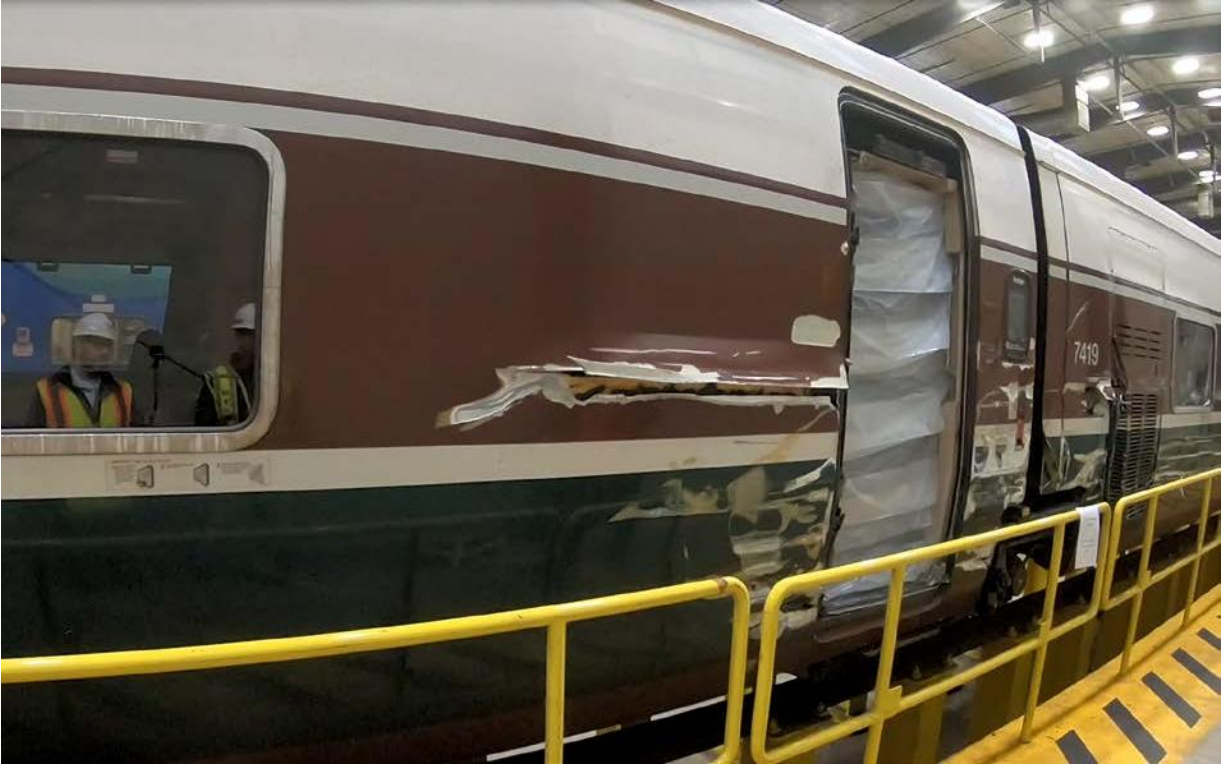
The damaged cars, AMTK 7522 and AMTK 7419, exhibited indications on the right sidewall of their car bodies consistent with a raking collision. AMTK 7522 exhibited two tears in the sidewall near the side passenger door. The door was also damaged during the collision and was removed during the recovery operation. See figure 3. The longest tear was measured to be about 4-feet in length occurring at the mid-point of the door, extending toward the passenger window. The other tear was measured at 18-inches in length. The side of the car was abraded from being in contact with the freight car. The height of the abrasion was measured at 38-inches. The passenger door was found inside of the car, placed there after the derailment. The damage to the side door is shown in figure 5. The door's window was broken, and the exterior aluminum covering was torn and damaged. Based on all observations to AMTK 7522, there were no indications passenger occupied space was compromised.

Figure 3. Damaged sidewall of AMTK 7522.

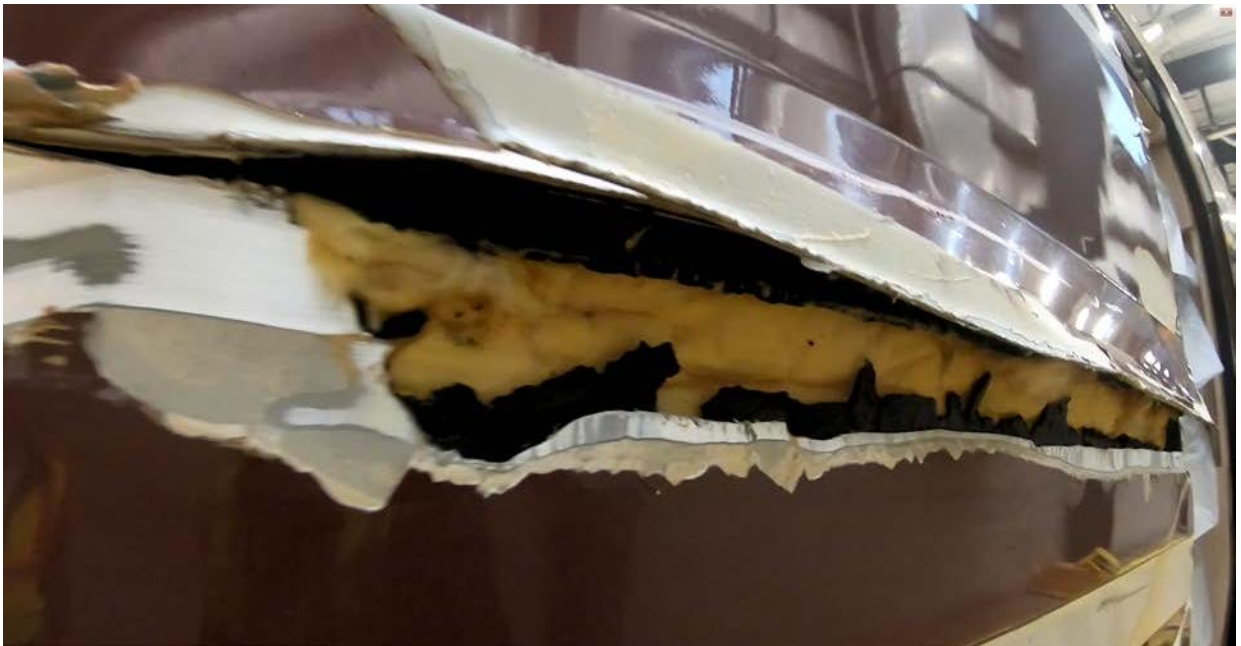
Figure 4. Close up view of the 4-foot tear on AMTK 7522.

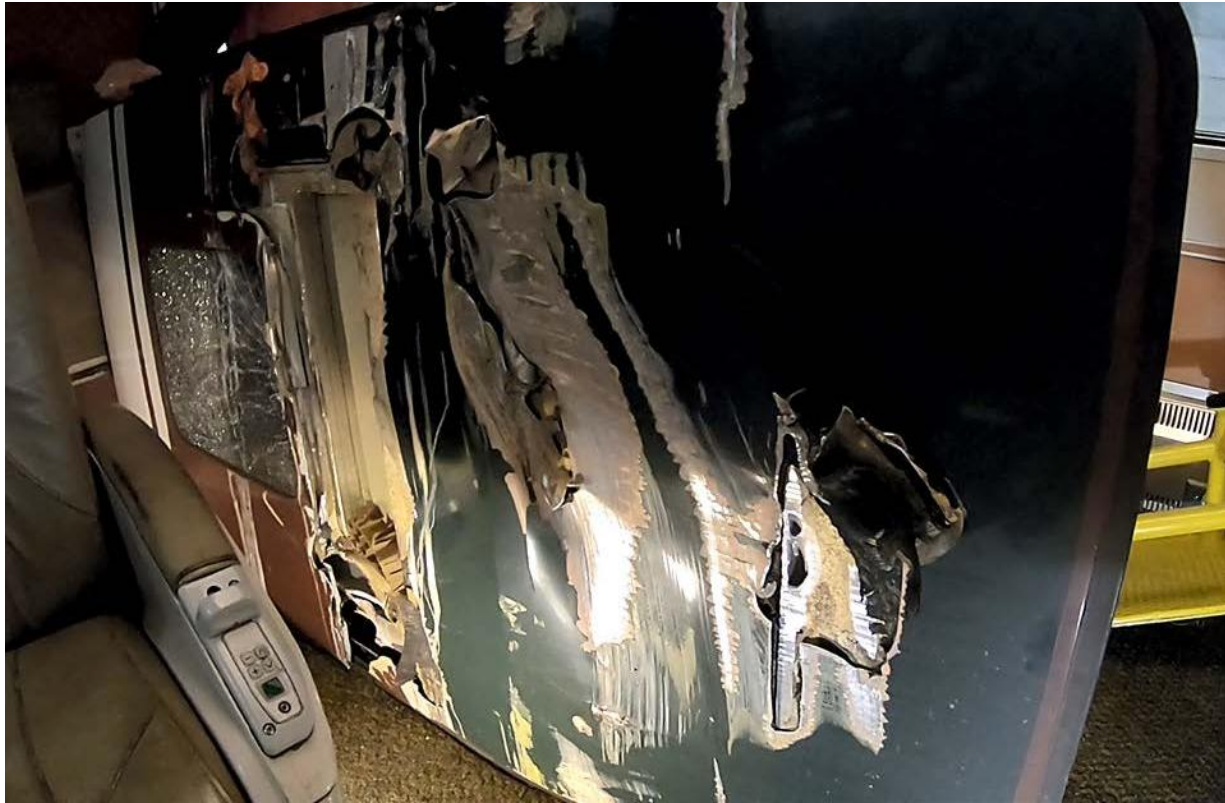
Figure 5. Damaged side passenger door from AMTK 7522 laying inside the coach.

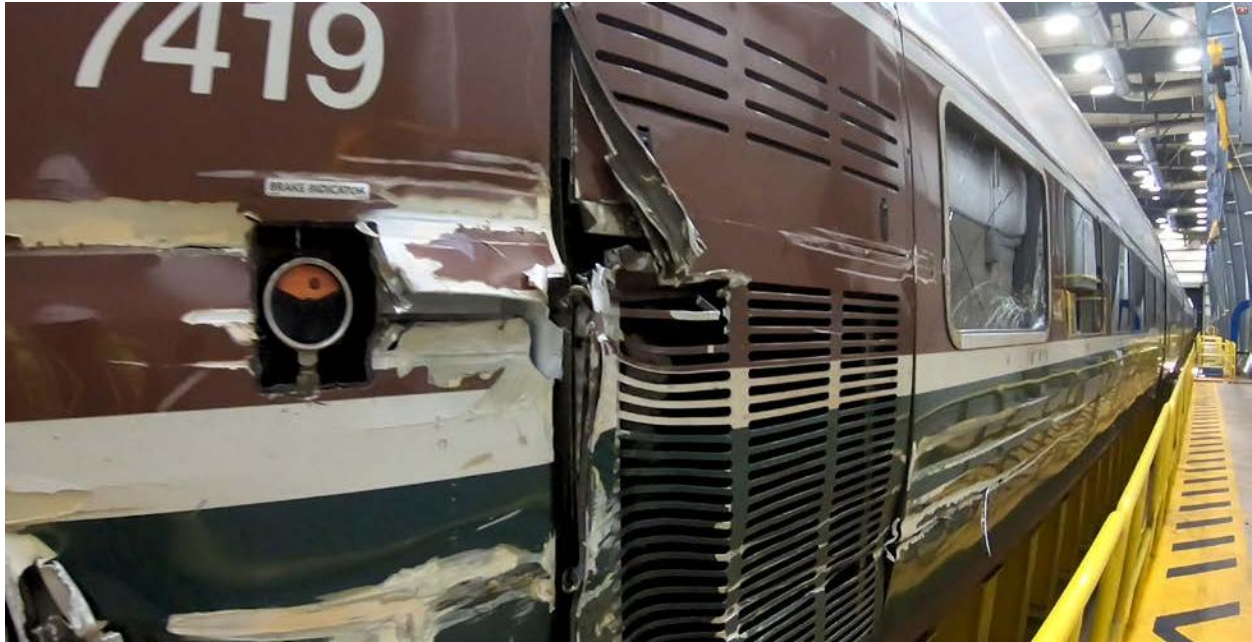
AMTK 7419 was abraded along its right side wall without significant compromise of the structure. See figure 6. There were two areas such that the sidewall was torn and fractured. One passenger window was broken, likely from contact with the freight car when it derailed.

Figure 6. Sidewall damage of AMTK 7419.

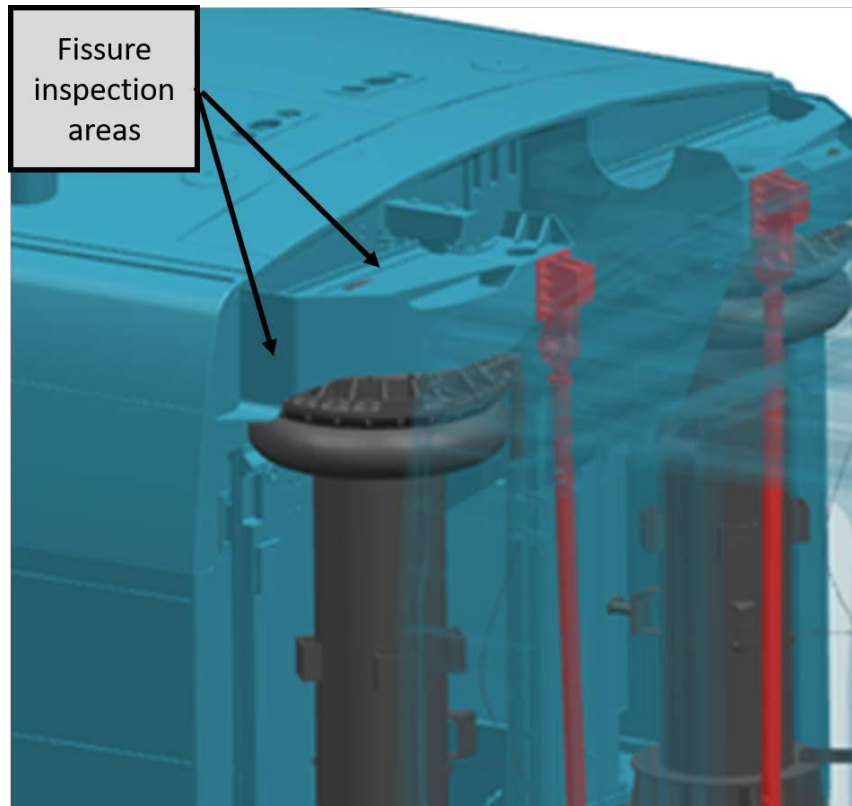
Figure 7. Fissure crack inspection areas.

The tower mount structures that are located on the supported ends of the Talgo Series VI trainset are located at the top of the end-wall, on the right and left side. The tower mounts began to experience fatigue failure (Amtrak defines this as ‘fissures’) in 2005 and require periodic inspections to monitor the issue. See figure 7. The tower mount fissure inspection was completed by Talgo personnel and witnessed by NTSB on AMTK 7522 and AMTK 7419. There were no fissure cracks identified. Additional examination of these mounts revealed no indication of failure.

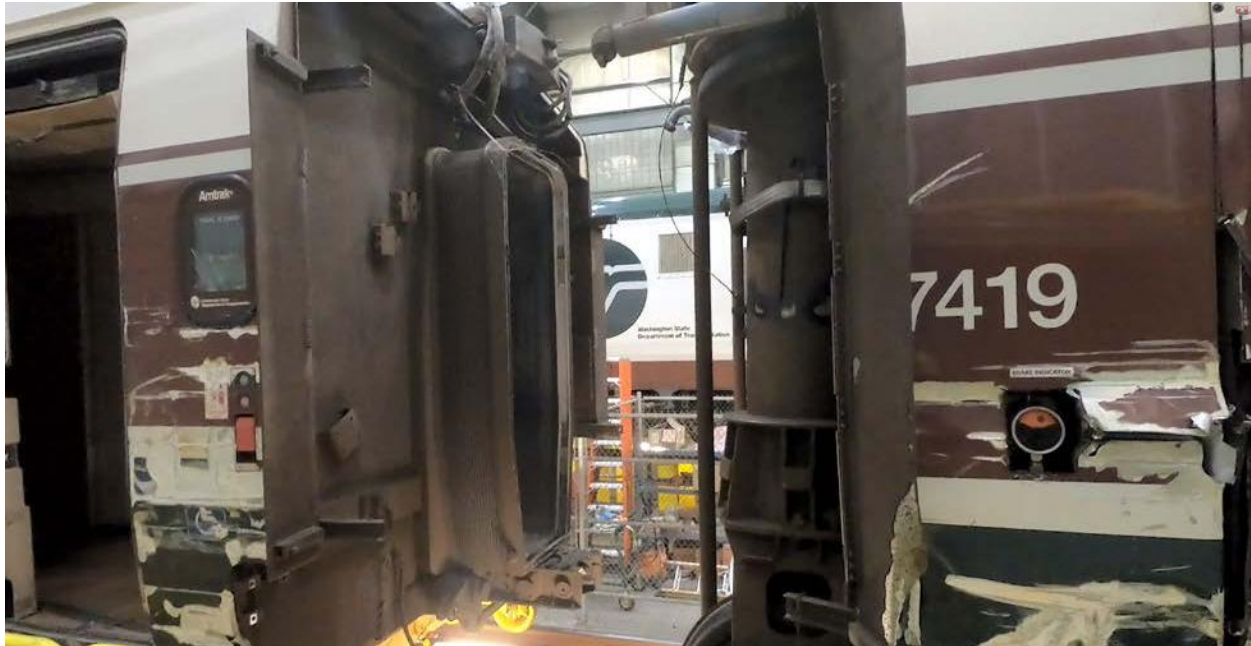
Figure 8. Separated cars, AMTK 7419 and AMTK 7522.

There was no significant structural damage observed to the end-walls of these cars. The articulated connection between the cars was visually inspected with no indication that it was overloaded or broken. The pin connection was removed from the draft pocket on AMTK 7522 by Talgo maintenance personnel and closely examined. No indications of overloading, bending or cracking were observed.
